IN-1185

October 1968

CORROSION EXPERIENCE WITH TYPE 316 STAINLESS STEEL  
IN SODIUM-POTASSIUM EUTECTIC ALLOY AT 1400°F

**IDAHO NUCLEAR CORPORATION**  
NATIONAL REACTOR TESTING STATION  
IDAHO FALLS, IDAHO

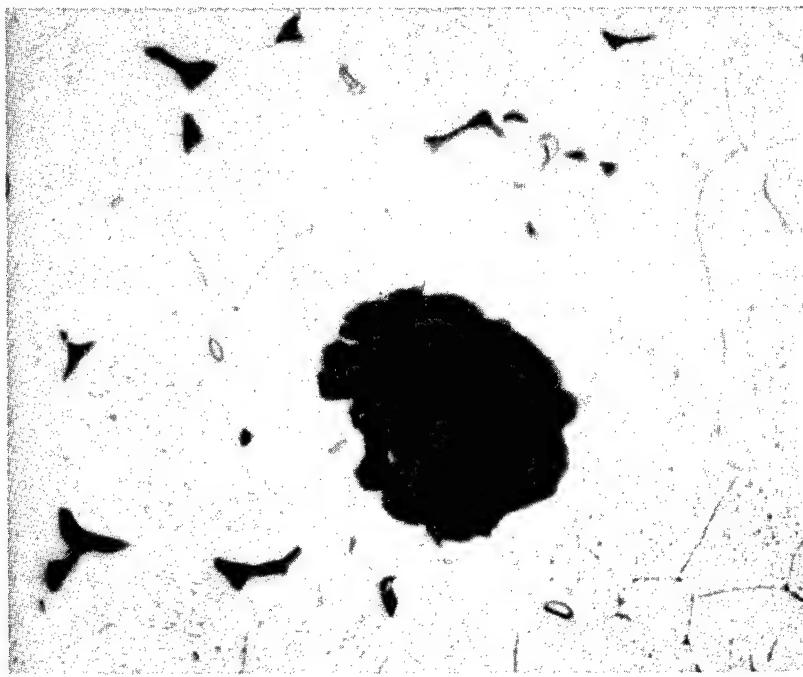
A metallographic examination of the piping indicated carbide precipitation at the grain boundaries and concentrations of up to 11 percent sigma phase as shown in Figures 6 and 7. A band of decarburized material 1 to 2 mils thick, was found on the NaK-side of the pipe wall, as illustrated in Figure 8. A 0.2- to 0.3-mil thick porous oxidation film was observed on the outer surface of the pipe wall, as illustrated in Figure 9. This film was only partially soluble in boiling nitric acid and was magnetic.

Figure 6 Sigma particle in cross-section of Type 316 ss pipe after 15,000 hours service at about 1400°F. Total Sigma is about 11%.

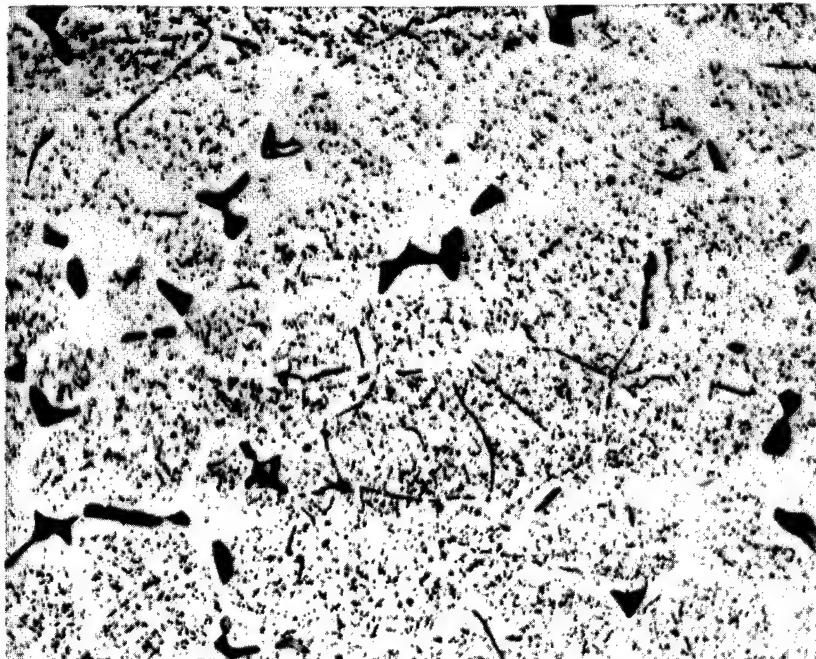
Figure 7 Cross-section of Type 316 ss pipe after 15,000 hours service at about 1400°F. Total Sigma is about 4%.

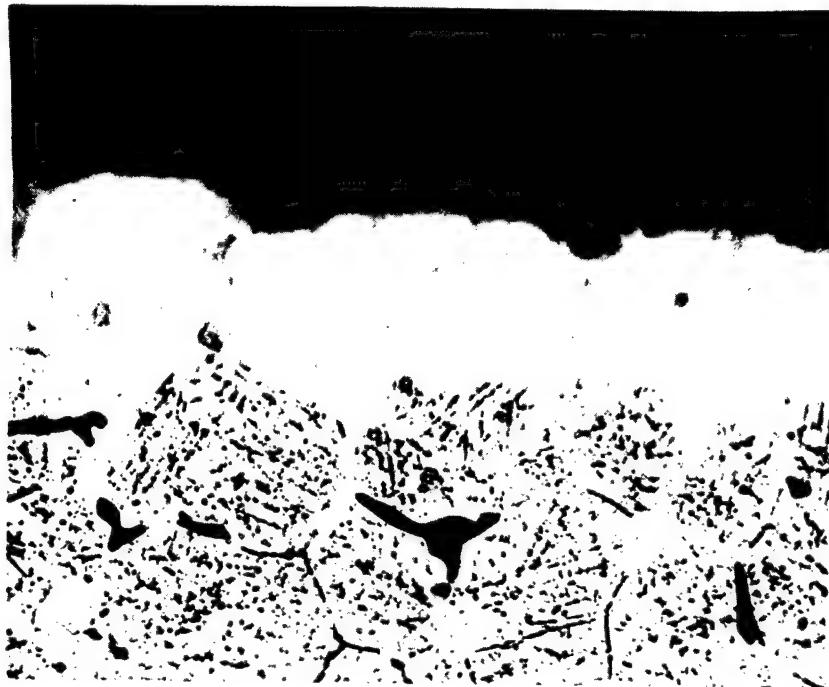
Figure 8 Decarburized zone of inside edge of 3-inch Sch. 40 Type 316 ss pipe after 15,000 hours service at about 1400°F.

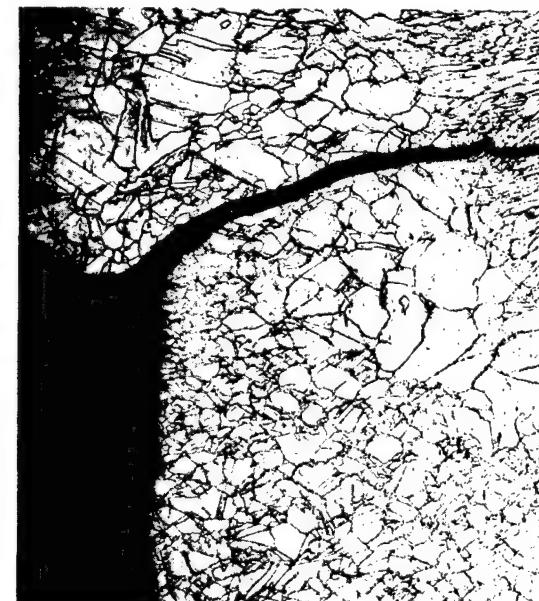
Figure 10 NaK expansion tank weld failure after 3,240 hours at 1100-1400°F service.

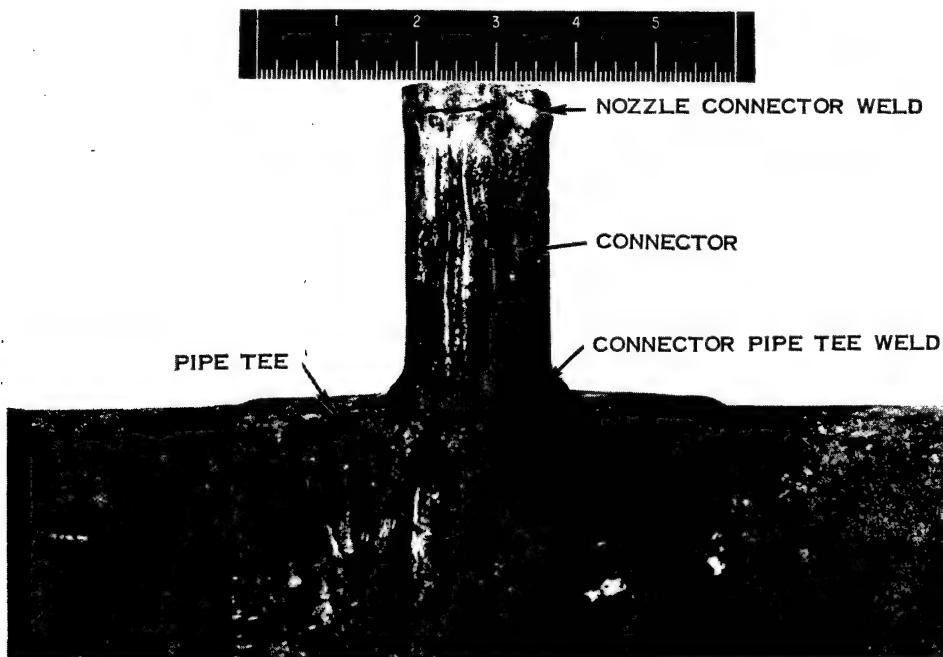
A service failure occurred at the weld joining a 1½-inch Schedule 40 pipe tee connector and the nozzle of a NaK expansion tank (Figure 11) after 3,240 hours service at 1100-1400°F and 360 hours service below

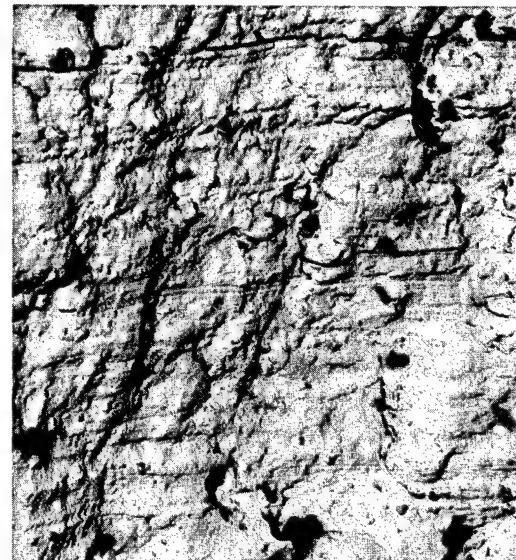
Figure 12 Surface topography of nozzle-connector weld failure after 3,240 hours at 1100-1400°F showing crack front arrest lines.

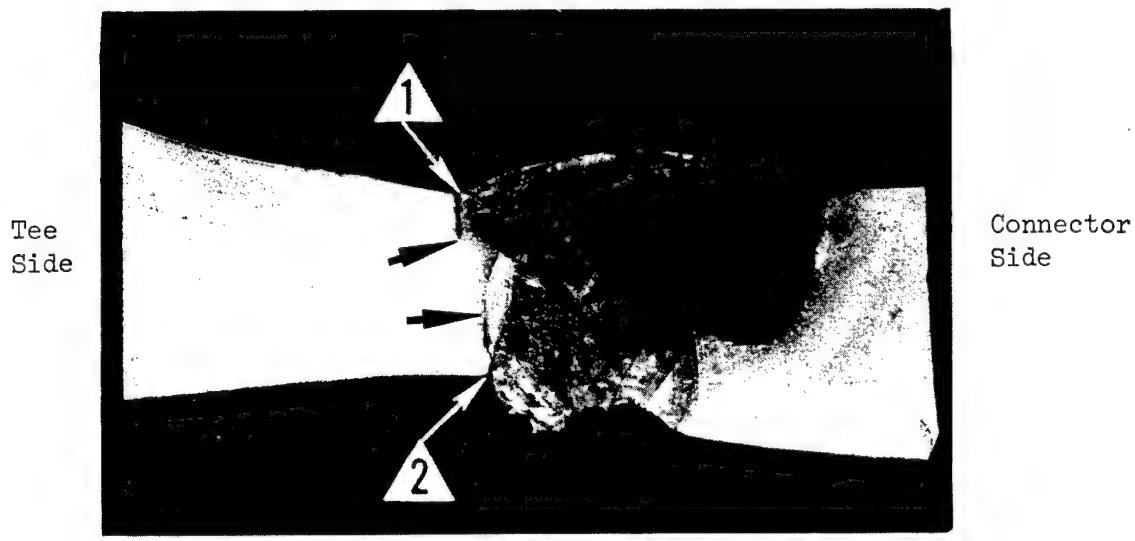
The crack on the outside of the tee-to-connector weld (tee side) was approximately 0.8-inch long. The crack on the inside of the same weld (also on the tee side) followed the edge of the weld around approximately 75 percent of the circumference. A photograph of these cracks is shown in Figure 13. In this figure, the crack on the outside penetrated 0.053 inches, the inside crack 0.047 inches, with 0.080 inches of sound metal between the crack terminations. The crack on the outside originated at the base of the weld bead at a sharp re-entrant angle. A further inspection showed the presence of a crack on the inner wall of the connector, Figure 14. The crack originating on the outside was lined with an oxide deposit while the inside crack was free of oxide. The three cracks were transgranular, as can be seen in Figures 15 and 16. A second transgranular internal (NaK side) crack, shown also in Figure 14, was found in the wrought pipe that was about  $\frac{1}{2}$ -inch from the tee-to-connector weld.

Figure 13 Cross-section through tee connector weld. White arrow 1 shows outside crack. White arrow 2 shows inside crack. Black arrows indicate crack terminations.

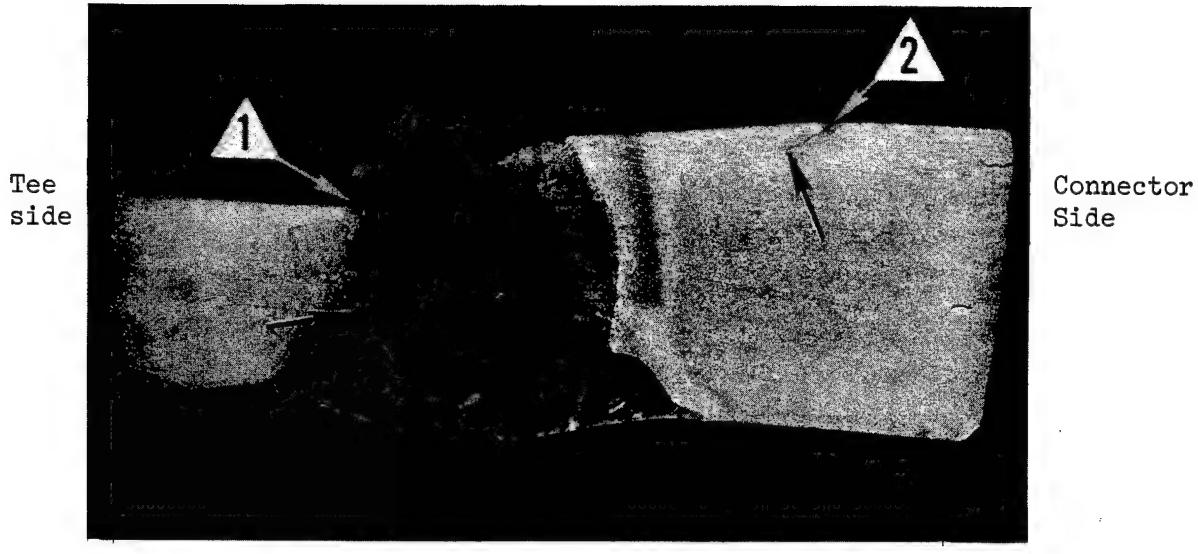
Figure 14 Cross-section through wrought connector. White arrow 1 shows crack on the inside at the base of the weld bead. White arrow 2 shows additional crack found on the inside of the connector. Black arrows indicate crack terminations.

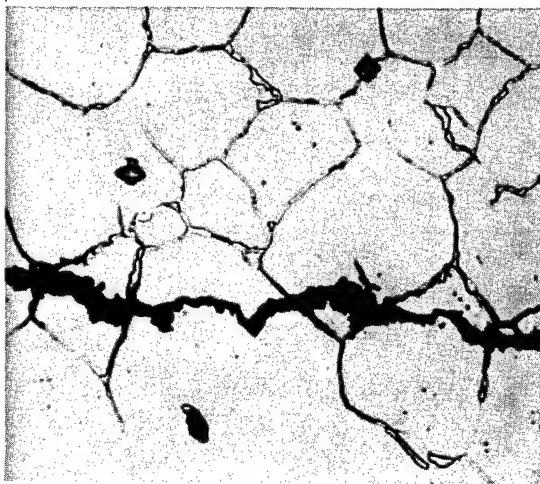
Figure 15 Internal crack in wall of pipe tee connector showing transgranular propagation after 15,800 hours service at about 1100-1400°F.

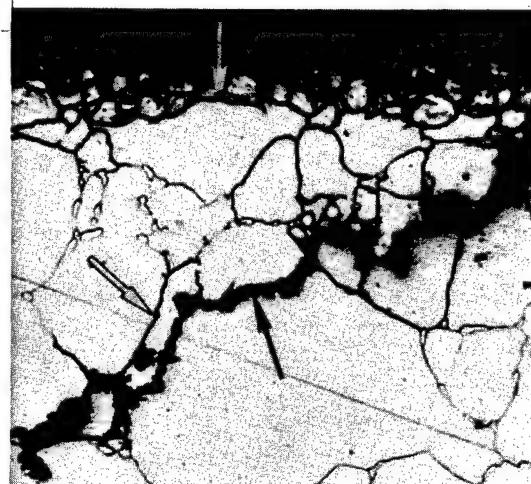
Figure 16 Crack on inside of pipe tee connector after 15,800 hours of service at about 1100-1400°F. Fine black lines indicated by white arrows are grain boundaries outlined by etching. Black arrow shows the crack.

By repolishing the samples once more and re-etching with Vilella etchant, sigma phase was tentatively identified as being the large microconstituents shown in Figures 19 and 20. These particles were stained various opalescent colors by Murakami's etchant; thus, further confirming the presence of sigma phase. The fine precipitates evident in Figure 18, are most likely chromium carbides since sigma phase forms

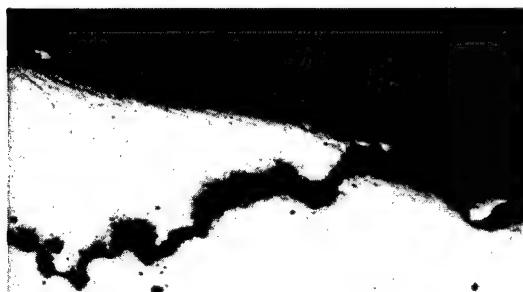
Figure 17 Internal crack in wall  
of connector. (Same area shown in  
Figure 16.)

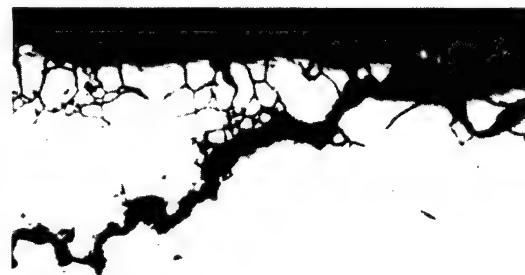
Figure 18 Internal crack in wall  
of connector. (Same area shown in  
Figure 16.)

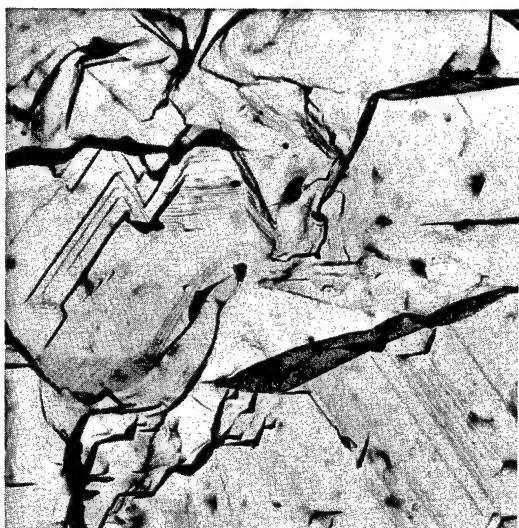
A section of the weld that joined the pipe tee to the connector, containing a representative portion of the inside and outside crack, was opened up by first cutting part way through the weld from the outside. The fracture surface of the inside crack was slightly tarnished and appeared to have been produced much later than the outside crack.

Figure 21 Surface topography of outside crack at the pipe tee connector weld.

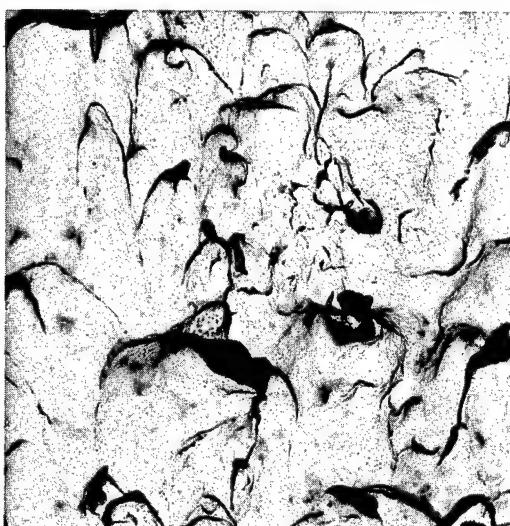
Figure 22 Surface topography produced by tearing material beyond the crack.

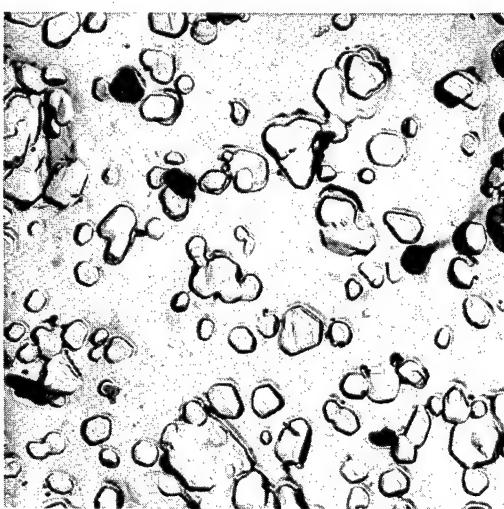
Figure 23 Surface topography of inside crack at the pipe tee connector weld.

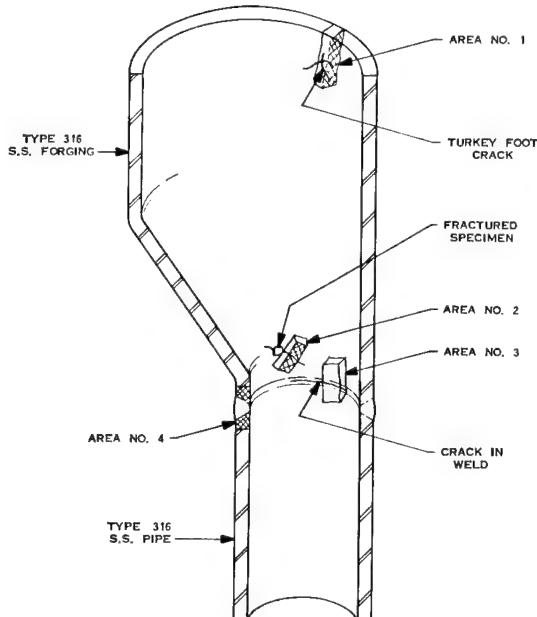
An investigation of the failure that occurred in the NaK drain line of the WCF indicated that residual and/or applied stresses cracked an eccentric reducer (Figure 24) in a manner characteristic of a brittle fracture. The weld joining this forged reducer to the 1 1/2-inch pipe suffered a ductile thermal fatigue fracture. Service time on this fitting was 19,080 hours at 1100-1400°F and 1,300 hours below 1100°F. There were 43 starts from room temperature.

Post-failure examination revealed two cracks in the reducer, and another crack in the weld that joined the reducer to the 1½-inch pipe. Both reducer and pipe were Type 316 stainless steel. Figure 24 shows the location of the three cracks. The cracks located at areas 2 and 3 in Figure 24 completely penetrated the forged reducer and weld, respectively, while the turkey-foot crack in area 1 was about 77 mils deep. Both cracks in the reducer were next to welds.

Figure 24 Diagram of 3-inch x 1½-inch eccentric reducer.

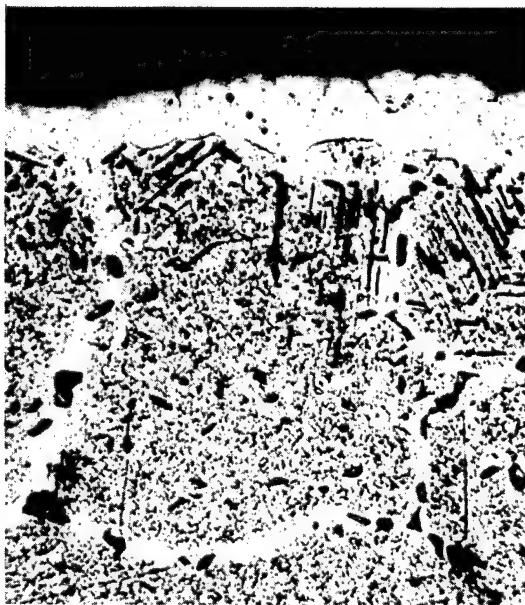
A metallurgical study of the reducer and weld at the cracks indicated that a decarburized zone occurred at the NaK stainless steel interface, Figure 25. Some grain dropping was observed in the decarburized zone, Figure 26. Sigma phase was observed at the root of the turkey foot crack, Figure 27, and in a cross-section of the weld in area 4, Figure 28. The massive disintegration of the forging at area 2, together with intergranular fracturing, is shown in Figure 29. A careful inspection of Figures 25 and 27 shows that carbides were precipitated at the grain boundaries of the forged reducer.

Figure 25 Decarburized zone of the inside surface of the reducer at Area #1 in Figure 24 after 19,100 hours at about 1100-1400°F.

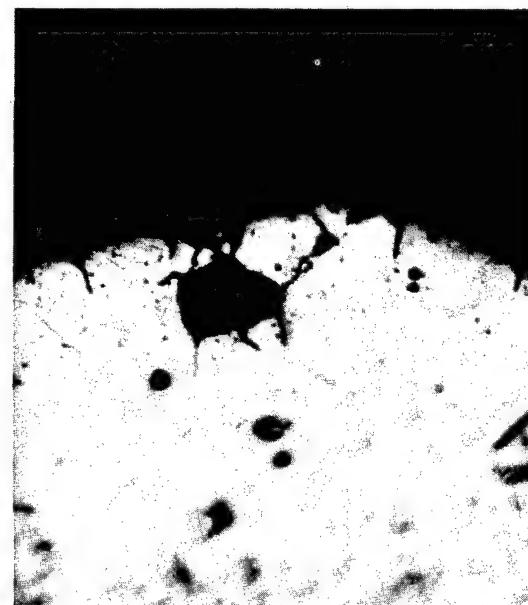
Figure 26 Grain dropping in the decarburized zone of the reducer at Area #1 in Figure 24 after 19,100 hours at about 1100-1400°F.

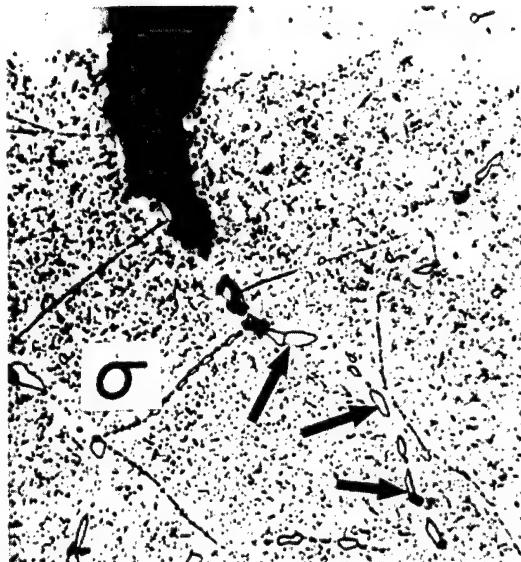
Figure 27 Root of the turkey foot crack on the inside surface of the reducer at Area #1 in Figure 24 showing sigma phase formation after 19,100 hours at about 1100-1400°F.

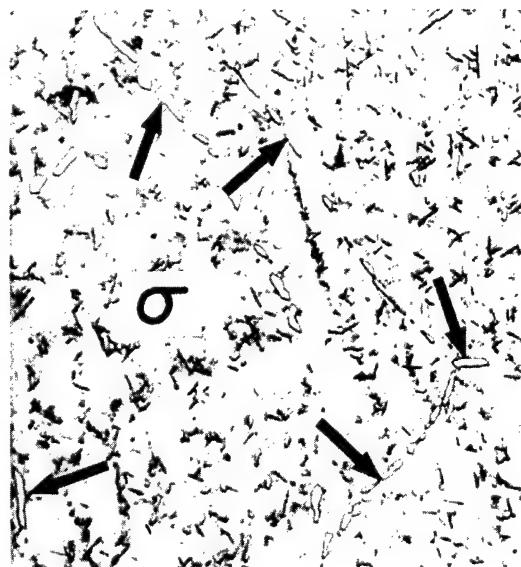
Figure 28 Weld at Area #4 in Figure 24 showing sigma phase formation after 19,100 hours at about 1100-1400°F.

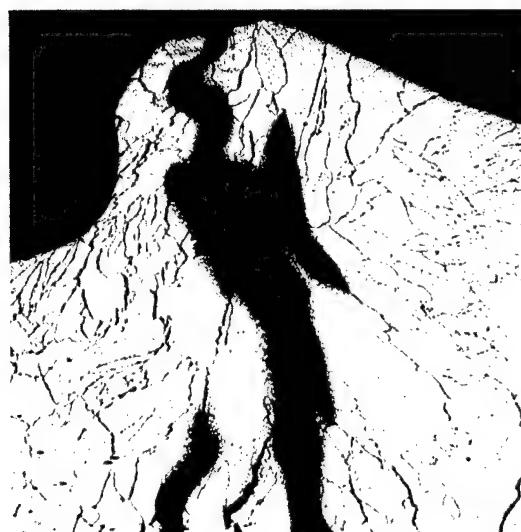
Figure 29 Cross-section of forging at Area #2 in Figure 24 showing intergranular fracturing after 19,100 hours at about 1100-1400°F.

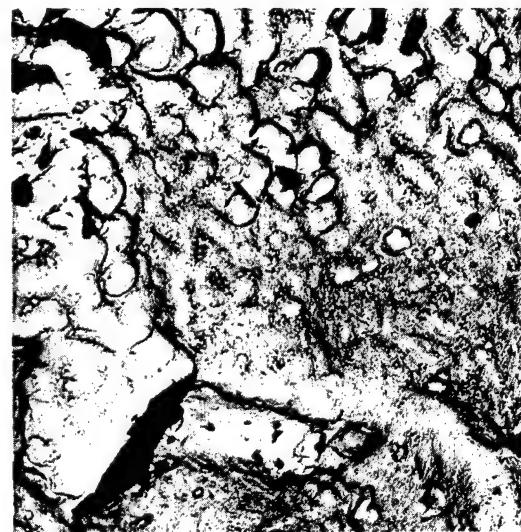
Electron microscopic fractographs of the fracture in the weld are typified by elongated dimples, Figure 30. These data suggest that shearing forces were imposed upon the weld, causing a ductile fracture. The fracture in the eccentric formed reducer has a cleavage type profile, Figure 31. This suggests that a brittle fatigue mechanism fractured the reducer.

Figure 30 Surface topography of the weld failure at the reducer to 1-inch pipe after 19,100 hours service at 1100-1400°F showing elongated dimples of ductile fatigue.

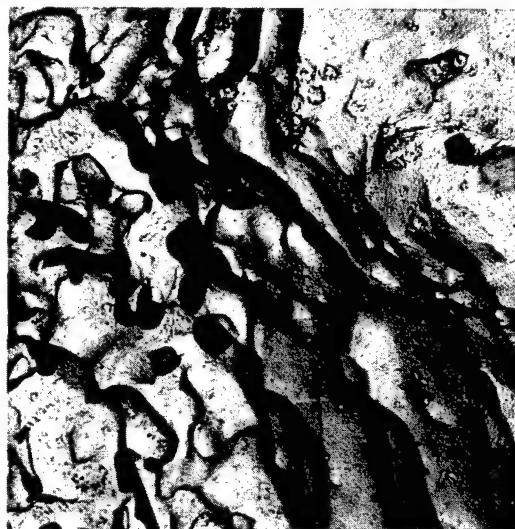
Carbon Replica 7700X  
Figure 31 Surface topography of the crack of the forged reducer at Area #2, after 19,100 hours service at about 1100-1400°F showing both elongated or tear dimples of ductile fatigue and intergranular brittle fatigue.

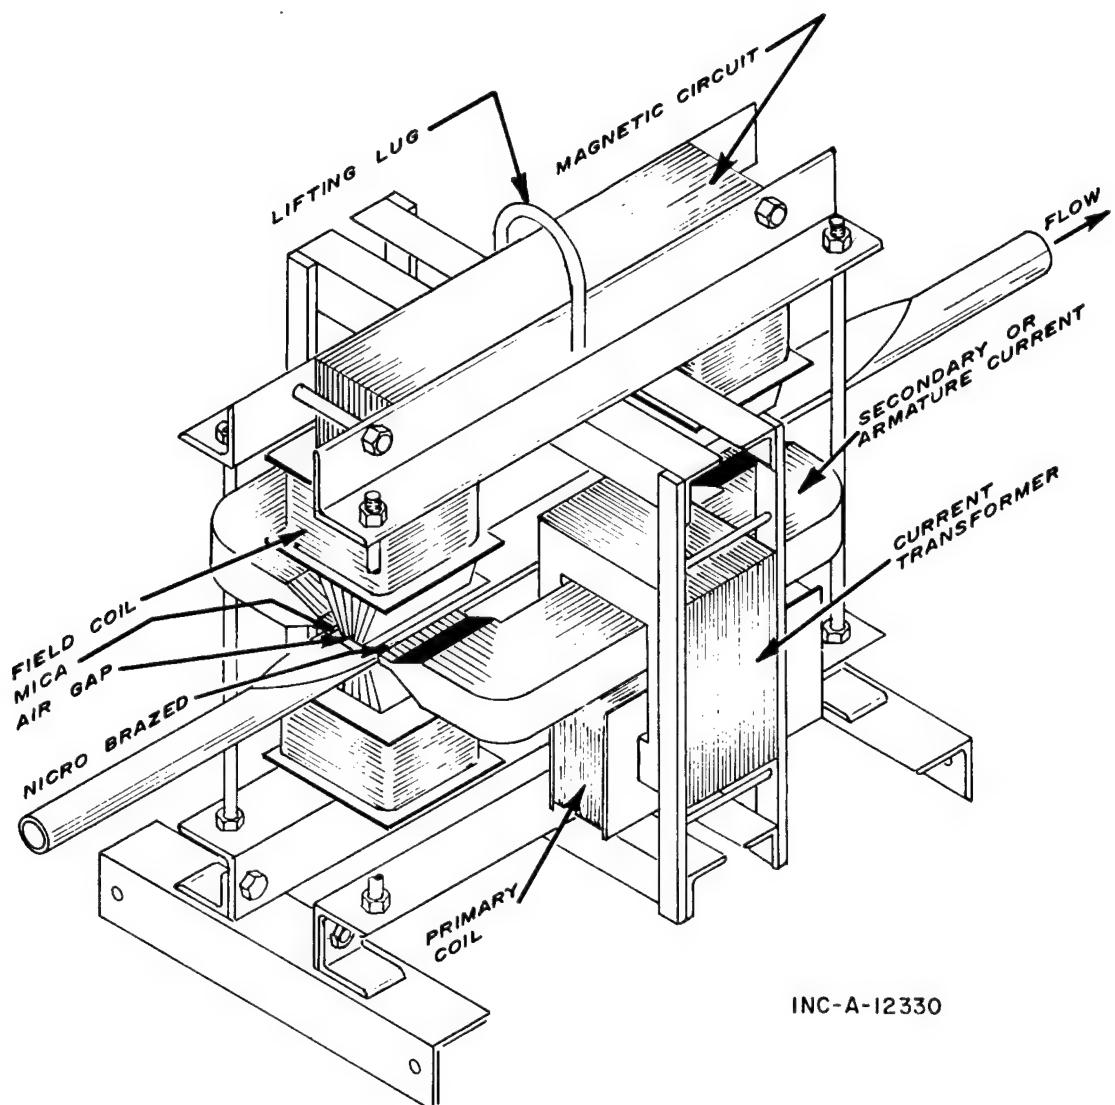
After dismantling the field coil, current transformers, and primary coils, a pin-hole was observed on top of the suction side of the pump tube just under the mica which insulates the field coil from the tube as shown in Figures 32 and 33. Using a 1/4-inch fly-cutter, the tube was machined to expose the NaK side of the pin-hole, Figures 34A, 34B, and 34C.

Figure 32 NaK electromagnetic pump.

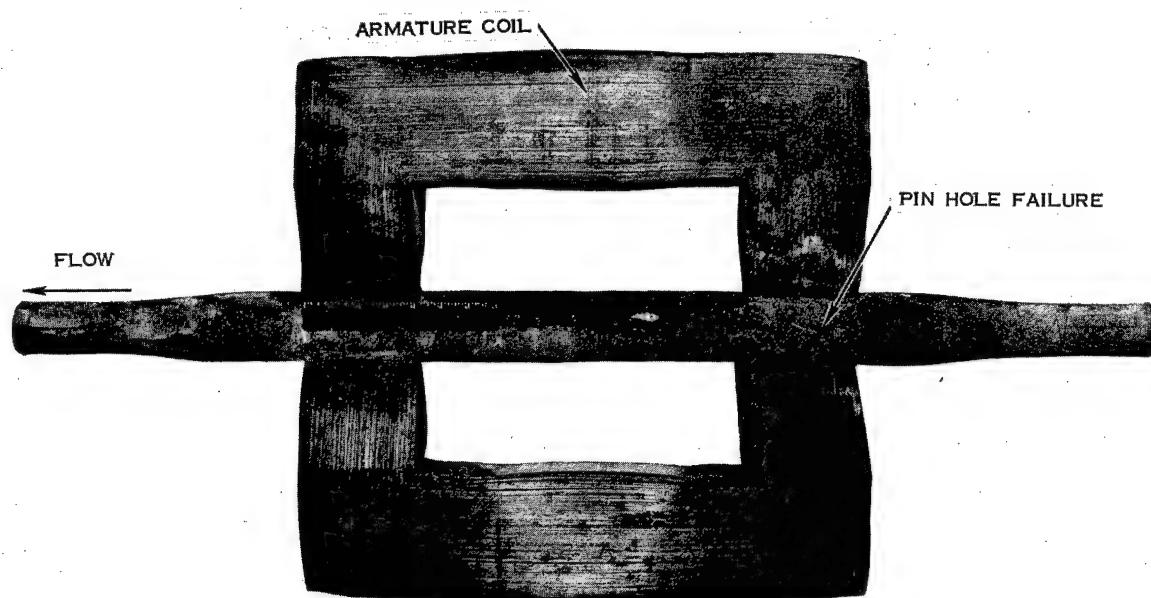
Figure 33 Dismantled NaK electromagnetic pump tube and armature coil.

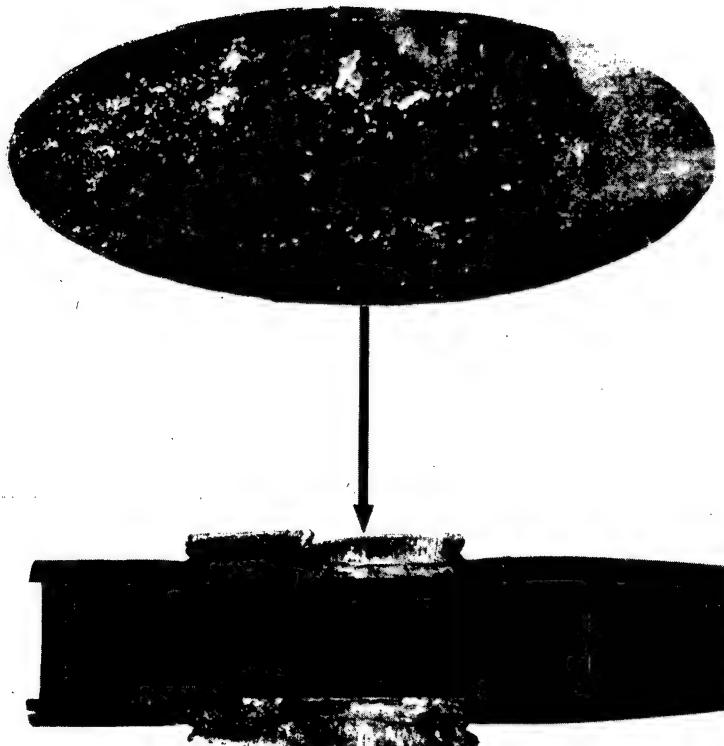
There is no complete explanation for this failure; although, there is considerable evidence of carburization of the pump tube, and this is an area where cavitation could occur.

Figure 34B Inside surface of pin hole failure of the EM pump tube.

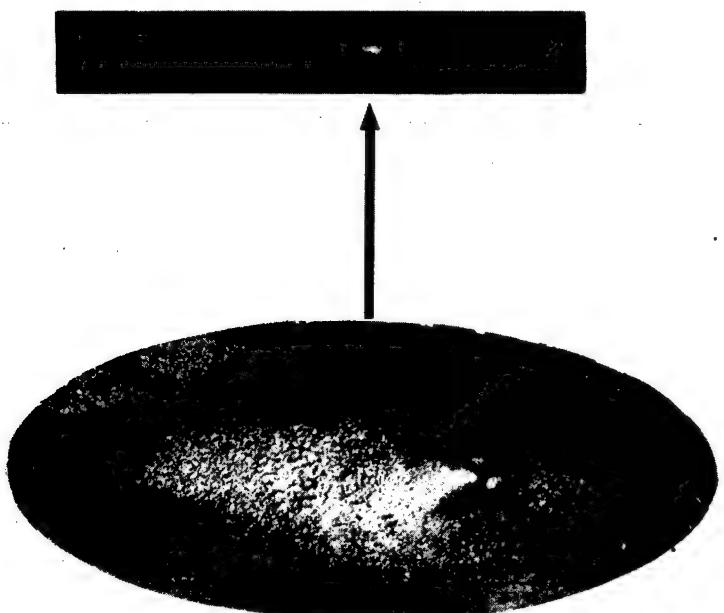
Figure 34A Inside surface of NaK EM pump tube after 20,100 hours at 1022-1400°F.

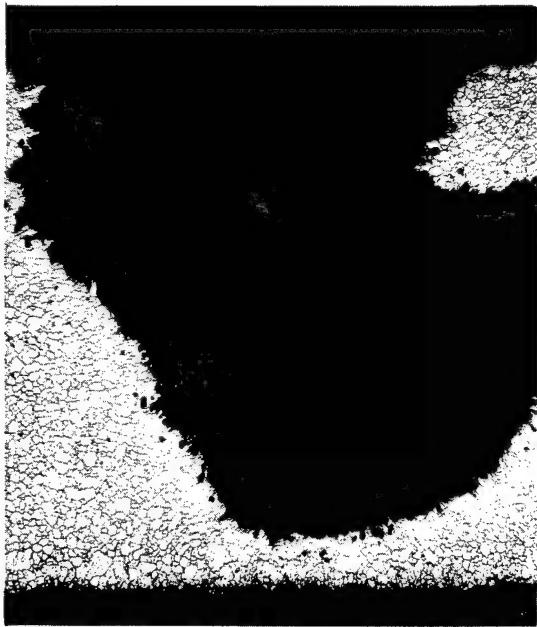
Figure 35 Cross-section of pin-hole  
in NaK pump tube after 20,100 hours  
at about 1022-1100°F.

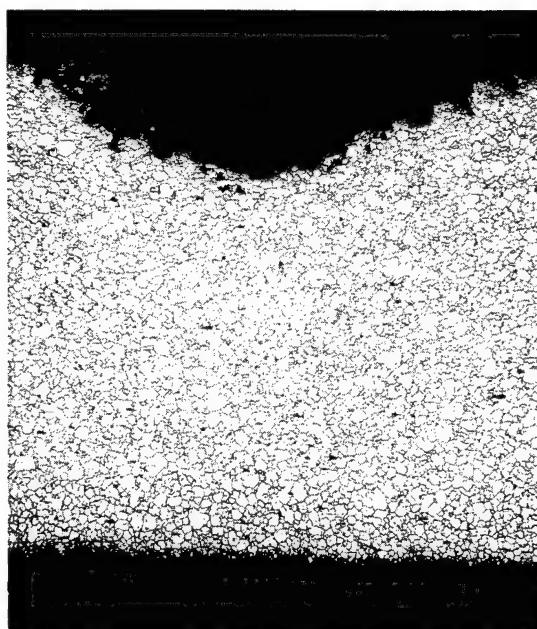
Figure 36 Cross-section of pit in  
NaK pump tube after 20,100 hours at  
about 1022-1400°F.

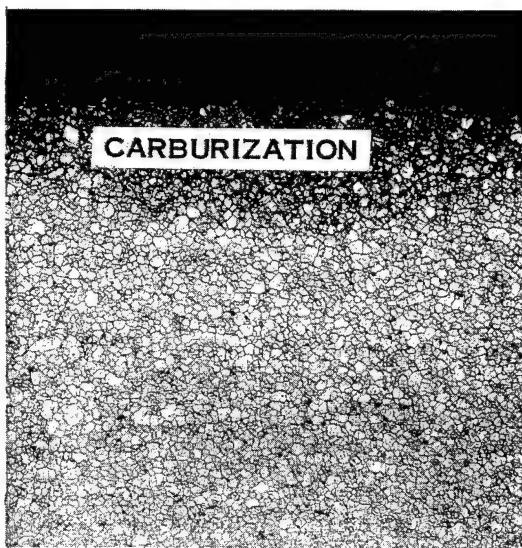
showed that these elements were lower in concentration at the carburized band than in the underlying Type 316 stainless steel. Chromium concentration in the band was 20 to 33 percent less than that in the base metal of the Type 316 stainless steel tube. Nickel concentration was constant throughout the various carburized regions but amounted to only 80 percent of that in the base tube; the molybdenum concentration was 50 percent of that found in the tube.

Figure 37 Cross-section of EM pump  
tube showing a carburization band  
on the NaK side of pump tube after  
20,100 hours at about 1022-1100°F.
